van der Meer, Jentsje; Nieuwenhuis, Jan-Willem; Steendam, Gosse Jan; Reneerkens, Michiel; Steetzel, Henk; van Vledder, Gerbrant
Wave Overtopping Measurements at a Real Dike

Wave Overtopping Measurements at a Real Dike

Abstract: Wave overtopping is not easy to measure in real situations. In a 12-years program wind, wave and water level conditions will be measured in a complex estuary, together with wave overtopping measurements at dikes. The first winter storm has been measured on 8 January 2019. Wave and water level conditions have been measured directly in front of the dike. Overtopping has been measured with two identical overtopping boxes that were placed in the dike, but at different levels. A measuring pole in front of the dike did measure wave and water level conditions already for 10 years and the design of the overtopping boxes was based on those data. This paper describes the analysis of those 10 years of measurements together with the recently measured storm that included wave overtopping. The overtopping box functioned well, but can be optimised for the next year. It appears that measuring in reality is not easy and one needs more time to fine tune the system. A first

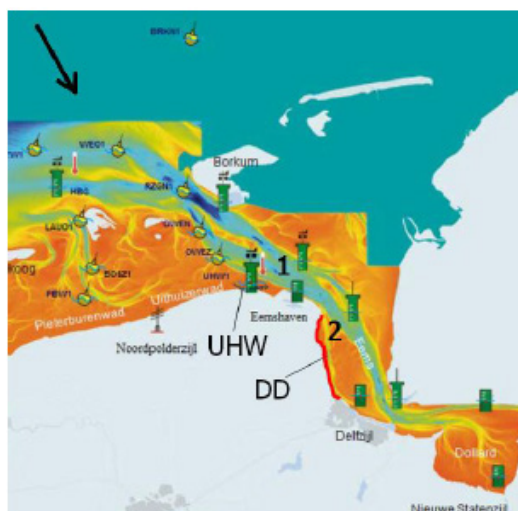
Fig. 1. Eems-Dollard estuary with the deep main channel (indicated by number 1), secondary channel Bocht van Watum (number 2), the dike section of interest (red line), the two locations of interest: Uithuizerwad (UHW) and the Double Dike (DD), and the typical wind direction during extreme conditions (arrow).

A twelve years long lasting research project has started in 2018. The focus of this study lies on the dike section between the Eemshaven (the main port in the area) and the town of Delfzijl, as indicated by the red line in Fig. 1. This dike protects a large part of the province of Groningen from flooding. A particular aspect for this area is that the design conditions for dikes are characterized by very obliquely incident waves, up to 80° relative to the dike normal. Extreme storms in the area tend to start out in the southwest and then turn to the northwest, but they never cross north to become eastward directed. This means, that at the dike of investigation, the wind is offshore directed during extreme conditions, as indicated by the arrow in Fig. 1.

The topic of this paper is on the measurements of wave overtopping at a real dike combined with wave and water level measurements directly in front of the dike. A measuring pole 100 m in front of the dike (location UHW in Fig. 1) exists already for 10 years, giving a good impression of the yearly extreme circumstances with respect to water level and waves. It is for this reason that this dike section has been chosen to measure also wave overtopping. From 2019 also wave overtopping will be measured at a dike section between Eemshaven and Delfzijl (see Double Dike DD number 2 in Fig. 1).

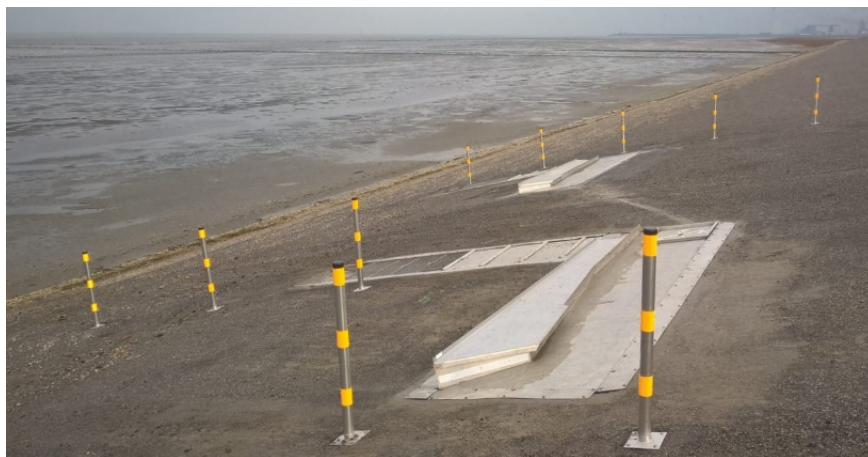
Fig. 2. The two wave overtopping boxes in the dike. The waves come from the left in the picture and can enter the boxes over a length of 4 m. The structures at the far side in the picture are the outflow channels.

Based on calculated maximum overtopping volumes and the time required for water to escape from the box, the dimensions of the boxes became 0.8 m deep, 1.3 m wide and 5 m long. The actual length of the opening for waves to enter the box was 4.0 m. At the end of the box an outflow was constructed for release of the overtopping water.

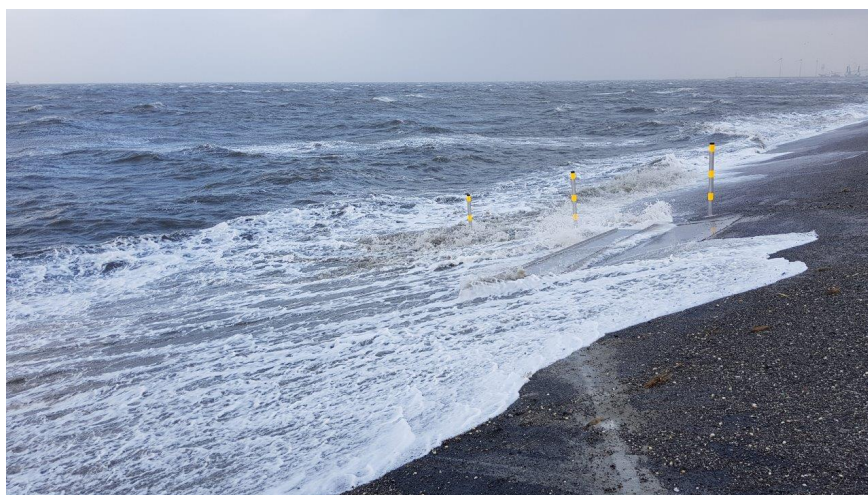
Fig. 3. An overtopping wave entering the lowest box on 8 January 2019.

Only one extreme storm occurred in the winter 2018/2019 on 8 January 2019, reaching a maximum water level of 3.19 m. The lowest box has measured many overtopping waves, the highest box only a few. Fig. 3 gives an impression during that storm.

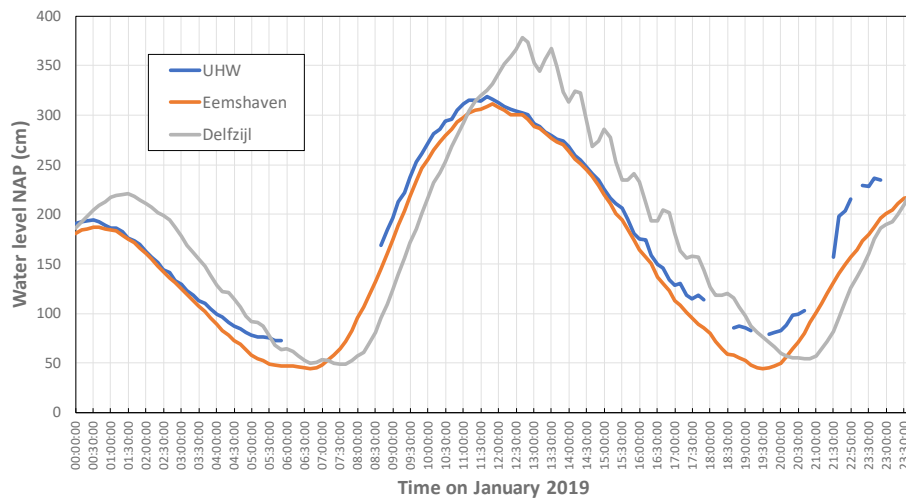
Fig. 4. Water levels measured on 8 January 2019 for the measuring pole (UHW) and two other places, see Fig. 1.

One storm has been measured when the overtopping boxes were present to measure wave overtopping. This storm occurred on 8 January 2019. Fig. 4 gives the water levels for the measuring pole at UHW, at Eemshaven about 4 km further and at Delfzijl, which is more to the south, see Fig. 1. The maximum water level was 3.19 m NAP with an average level around the peak of 3.15 m NAP, which is well above the critical storm surge level of 2.5 m NAP. These measurements can be compared with previous measurements of extreme water levels.

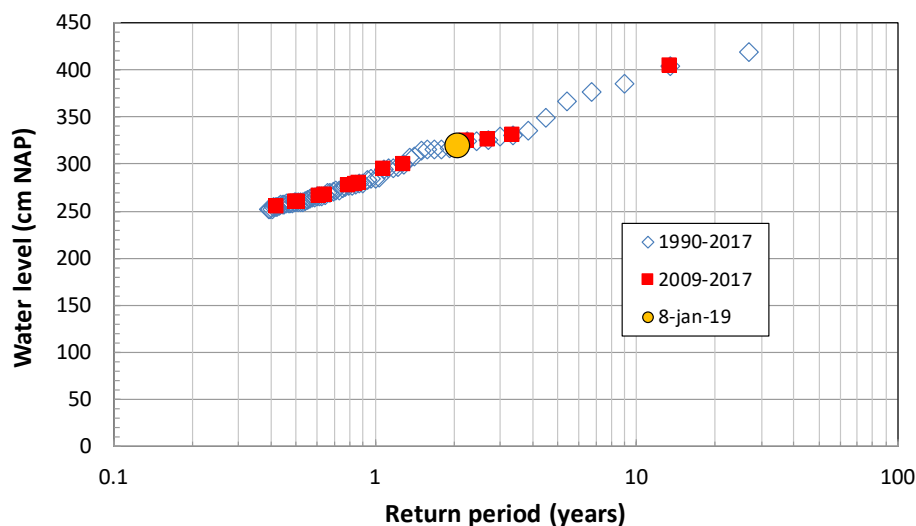
Fig. 5. Extreme water levels over the period 1990-2017, the period 2009-2017 when the measuring pole was present and the water level during the storm of 8 January 2019.

Water levels at the Eemshaven have been measured for a long time and the extreme levels have been given for about the last 30 years in Fig. 5. The 17 selected storms in the period 2009-2017 show only one water level higher than 3.5 m NAP. From the 17 storms in this period only 4 water levels were higher than the water level during the storm of 8 January 2019. This means that this storm had a water level that agrees well with the expected level that may be exceeded in the next 11 years for only a few occasions.

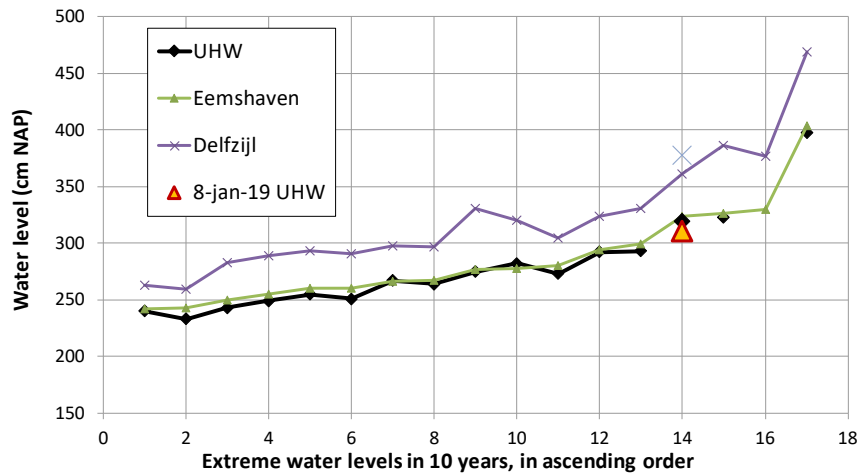
Fig. 6. Extreme water levels for 17 storms in the period 2008-2017 for 3 stations and the measurements on 8 January 2019.

This can also be concluded from Fig. 6, where the water levels of the 17 selected storms are given in ascending order and for 3 locations. The figure also shows that there is quite a good correlation between the water level measurements at the three stations given. The average extreme water level during the peak of a storm at Eemshaven is 0.04 m higher than the average extreme water level at UHW. The difference in averages between Eemshaven and Delfzijl (see Fig. 1) is 0.32 m. As the Double Dike section (DD in Fig. 1) is a little less than half way between Eemshaven and Delfzijl, the expected average extreme water level at DD is then about 0.15 m higher than at the Eemshaven. This can be used to design the overtopping boxes for the DD in 2019.

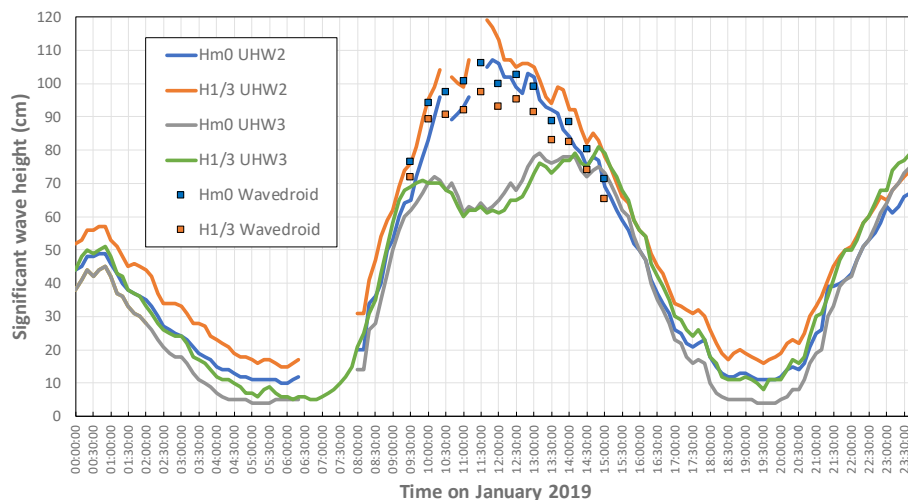
Fig. 7. Wave heights during the storm of 8 January 2019 for three devices at the same location.

Fig. 7 gives the wave heights over the full day of 8 January 2019. The spectral wave heights, H_{m0} , are given as well as the significant wave heights from the time domain, $H_{1/3}$. The step gauge UHW3 and radar UHW2 give measurements over a period of 10 minutes. The Wavedroid gives measurements over 30 minutes. The radar missed some periods during the peak of the storm. The radar and Wavedroid give wave heights in the same range, the step gauge heights did not increase during the peak of the storm and it must be concluded that the measurements by the step gauge at that time are not correct. It can also be concluded that the H_{m0} of the radar UHW2 and Wavedroid are quite similar, where the $H_{1/3}$ of the radar is higher than these measurements and the $H_{1/3}$ of the Wavedroid lower. As a preliminary conclusion it seems that the H_{m0} is the most reliable measure.

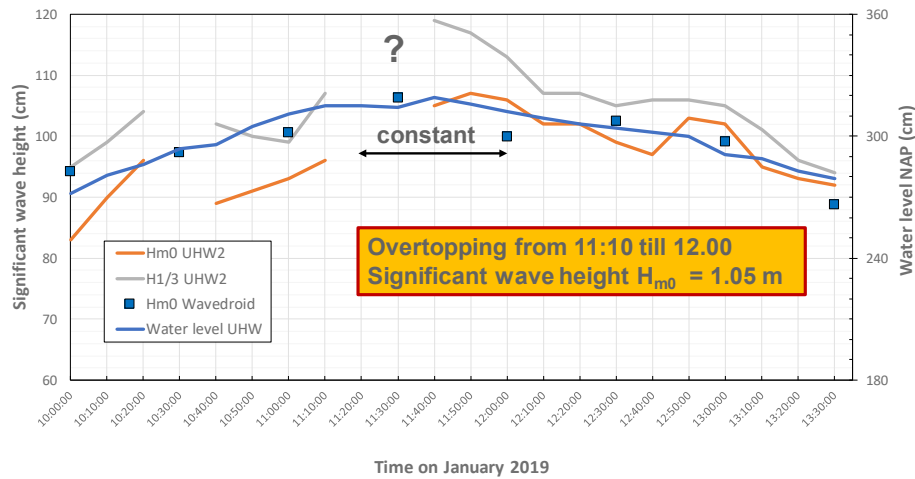
Fig. 8. Wave heights and water levels during the peak of the storm of 8 January 2019.

Fig. 8 gives the details of Fig. 7, during the peak of the storm. Also the water level is given. The water level is more or less constant between 11:00 and 12:00, but the wave height at 11:00 is significantly lower than between 11:40 and 12:00. The radar UHW2 gives no measurements for two periods (11:20 and 11:30), but the wave droid gives the 30 minute measurement, which is similar to the wave height H_{m0} of the UHW2 for the periods 11:40 to 12:00. Based on these measurements it was assumed that a constant sea state (constant in water level and wave height) was present during the measurements 11:20 till 12:00, with a wave height $H_{m0} = 1.05$ m. As the measurements took 10 minutes and the data are given after the measurements, the time that the sea state was considered present is from 11:10 to 12:00, which is 50 minutes. This is the time that also wave overtopping circumstances should be considered as constant. Fig. 9 shows the unfiltered water levels of the lowest overtopping box during the storm and indeed the given period to some extent shows a more or less constant behaviour.

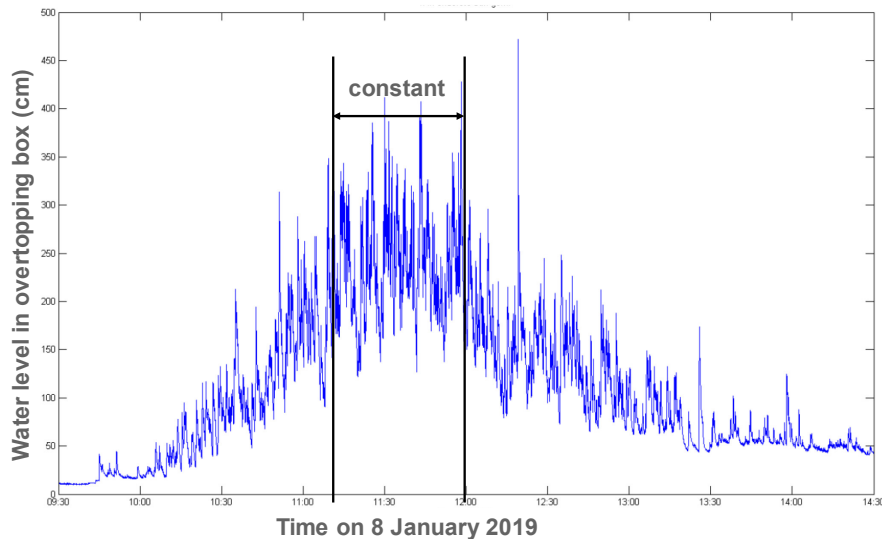
Fig. 9. The water level in the lowest overtopping box, giving a more or less constant picture between 11:10 and 12:00.

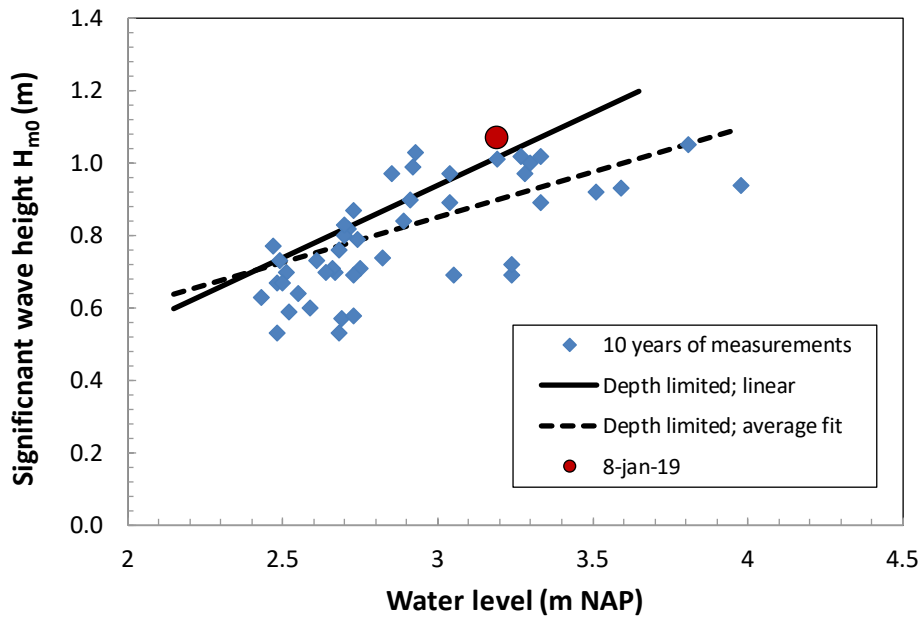
Fig. 10. Wave height – water level trend for 10 years of measurements and for the storm of 8 January 2019.

Fig. 10 shows the wave height of $H_{m0} = 1.05$ m and water level 3.15 m NAP of the January storm together with the 10 years of measurements at the pole. It should be noted that the 10 years of measurements are from the step gauge UHW3, which did not measure correctly for the January storm (see Fig. 7) and that the January storm is given by the radar measurements UHW3. The step gauge gave quite some scatter, which is believed to be caused by less reliable measurements.

All wave heights in Fig. 10 are depth limited with the foreshore depth at about 0.65 m NAP. A linear relationship was determined as well as a best fit on the measurements:

The wave height of 1.05 m during the January storm is close to the line of Eq. 1, but is also the highest wave height measured. This is quite surprising as the water level was not the highest measured in the past 10 years, nor was the wind velocity highest. There might be a bias between measurements with a step gauge and with radar, which should be investigated further.

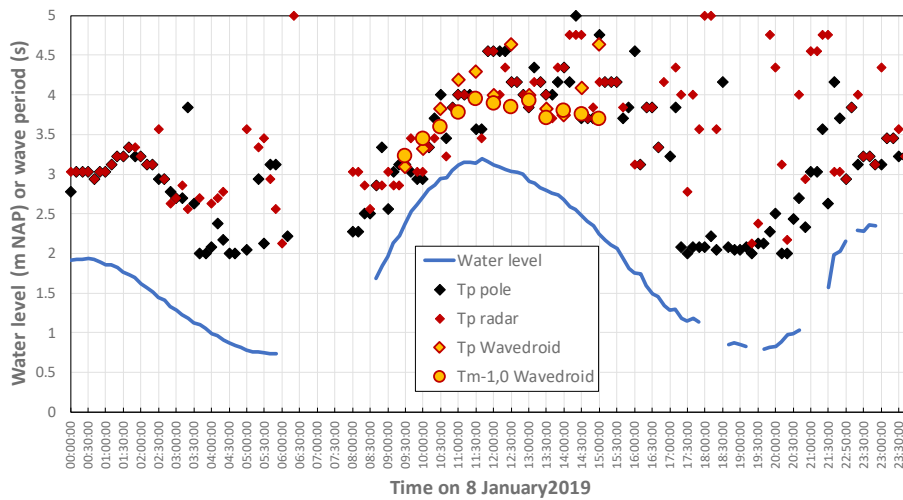
Fig. 11. Wave periods and water levels measured during the storm of 8 January 2019.

Fig. 11 gives the measured wave peak periods T_p for the pole, radar and Wavedroid, which give quite a similar trend. The periods increase during raising water level and reach their maximum value at the peak of the storm and then remain more or less constant for some time. The spectral period $T_{m-1,0}$, which was measured by the Wavedroid, shows the same trend. The peak period at the peak of the storm was $T_p = 4.3$ s and the spectral period $T_{m-1,0} = 3.9$ s.

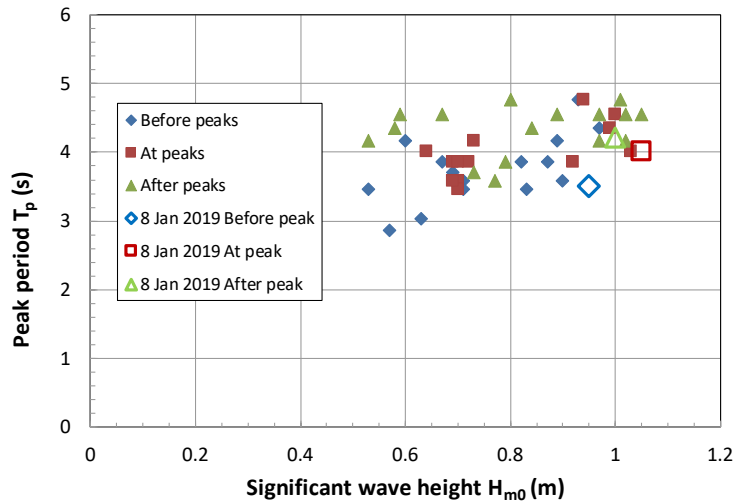
Fig. 12. Peak wave periods T_p before, at and after the peak of the storm, for 10 years of measurements and the storm of 8 January 2019.

Fig. 12 shows the measured peak periods in 10 years with measurements before, at and after the peak of the storm. The picture is similar as in Fig. 11: an increasing period till the peak of the storm and a constant or slightly increasing peak period after the peak of the storm. The data of the January storm coincide well with the earlier measurements, giving more or less a peak period of 4 s regardless of wave height.

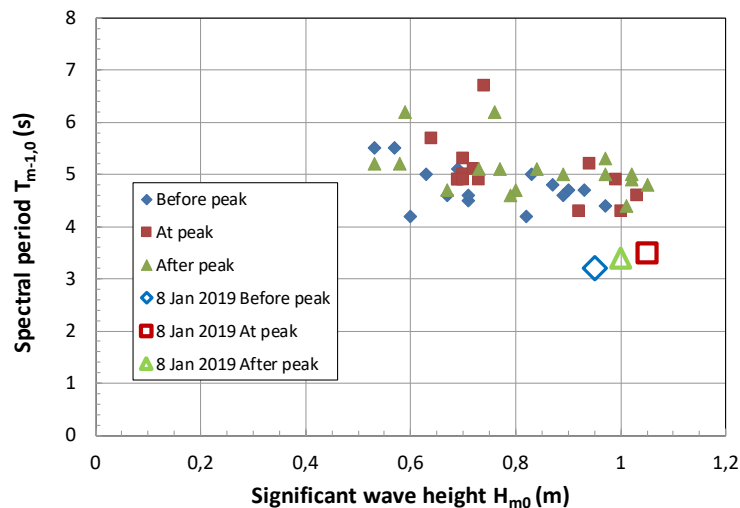
Fig. 13. Spectral wave periods $T_{m-1,0}$ before, at and after the peak of the storm, for 10 years of measurements and the storm of 8 January 2019.

Fig. 13 shows a similar graph as in Fig. 12, but now for the spectral period $T_{m-1,0}$. The trend over the peak is similar as for the peak period, but the periods for the January storm are significantly smaller than for the 10 years of measurements. The 10 years of measurements were taken from the step gauge UHW3 and the January storm was taken from the Wavedroid. The average value for the step gauge is about 5 s, which is 25% larger than the peak period of 4 s. For a single peaked spectrum the spectral period is often 10% smaller than the peak period (EurOtop, 2018). The spectral period measured with the Wavedroid is 3.9 s and this is indeed about 10% smaller than the peak period. Also here further investigation is needed as the expected wave overtopping is highly dependent on the spectral wave period.

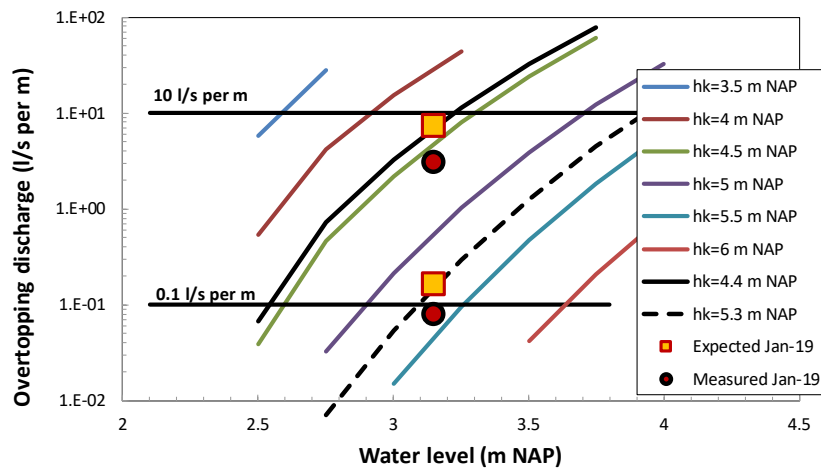
Fig. 14. Overtopping calculations for various crest levels in order to determine the levels for two overtopping boxes. The final levels where 4.4 m NAP and 5.3 m NAP, also given in the graph together with the predictions and measurements for the January storm.

Wave overtopping calculations have been made using EurOtop (2018), specifically Equations 5.1 and 5.2 for the 2% run-up level; Eqs. 5.10 and 5.12 for the wave overtopping discharge; Eq. 5.56 for the percentage of overtopping waves; and Eqs. 5.52, 5.53 and 5.57 for the maximum volume in overtopping waves. For the wave height Eq. 1 has been used, which is dependent on the water level. The spectral period was taken as 5 s and the angle of wave attack 50° as well as 65° with respect to the normal of the dike. The actual profile of the seaward slope was taken and the average slope angle was determined for each water level, as the dike slope is a little concave and not straight. Fig. 14 shows the results of many calculations. For crest levels of 3.5 m NAP up to 6 m NAP the overtopping discharge was calculated. The lowest box should measure from a water level of 2.5 m NAP and the highest box should take over when the lowest box would be overrun by waves, which was estimated for overtopping discharges larger than about 10 l/s per m. Based on graphs like in Fig. 14 it was decided to construct the lowest box at a level of 4.4 m NAP and the highest box at 5.3 m NAP. These lines have also been given in Fig. 14. Fig. 2 gives the boxes as constructed and Fig. 3 an impression of the wave overtopping in the lowest box for the January storm.

With a water level of 3.15 m NAP an overtopping discharge was expected of 7.3 l/s per m, where the actual overtopping in the January storm was 3.04 l/s per m. But this was based on a spectral wave period of 5 s. With a period of 4.31 s the wave overtopping would already be equal to the expected one, which validates again the conclusion that more investigation is needed for the wave period. The highest overtopping box got 6 overtopping waves, giving an overtopping discharge of 0.079 l/s per m, where 0.163 l/s per m was expected for a wave period of 5 s.

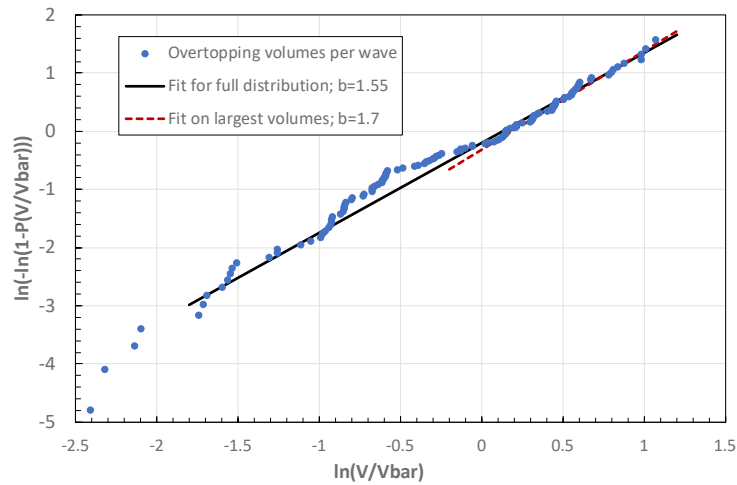
Fig. 15. Distribution of overtopping wave volumes at the January storm on a Weibull graph.

The volume of each overtopping wave in the lowest box and in the period 11:10 to 12:00 of 8 January 2019 was determined. In total 121 overtopping waves were detected, giving an overtopping discharge of 3.04 l/s per m. EurOtop (2018) gives a prediction of the shape parameter b of the distribution of overtopping wave volumes. The 121 overtopping volumes were first plotted on a Weibull graph as in Fig. 15 in order to determine the b -value. This b -value is the inclination of the line on such a Weibull

graph. A b-value of 1.55 was found for fitting on the highest part of the overtopping volumes and a little larger value of 1.70 for the whole distribution. In case of deviation one should always concentrate on the fitting the largest volumes, see Zanuttigh et al. (2013). A value of 1.6 was taken for further analysis.

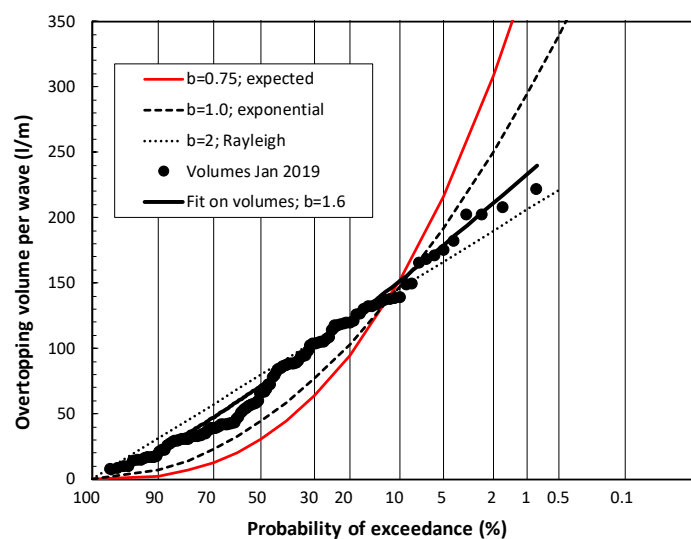
Fig. 16. Distribution of overtopping wave volumes at a Rayleigh scale, including the January storm.

The expected b-value for not too large wave overtopping on a smooth structure is around $b = 0.75$, which is steeper than an exponential distribution with $b = 1$ and much steeper than a Rayleigh distribution with $b = 2$. Distributions with these b-values are given in Fig. 16, together with the measured distribution. The difference between the measured and expected distribution ($b=0.75$) is very large. The maximum overtopping volumes may differ up to a factor of 2!

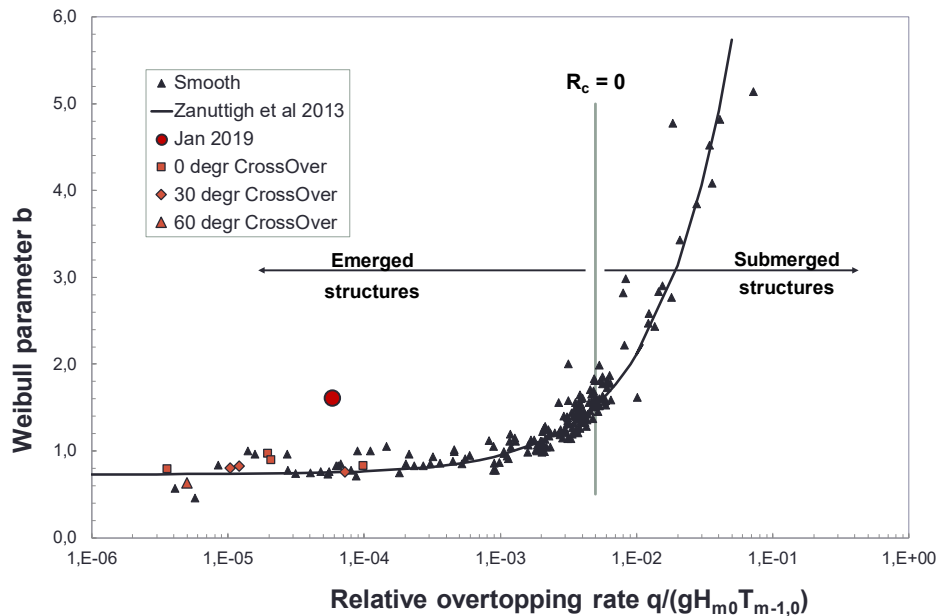
Fig. 17. EurOtop Fig. 5.40 with the b-value for the January 2019 storm and recent measurements in a wave basin.

The value of 1.6 was also plotted in the EurOtop (2018) graph, together with recent measurements in a wave basin and oblique wave attack on a 1:3 smooth slope (CrossOver project, Leite et al. (2019)). The laboratory measurements fit quite well with earlier measurements; the January storm does not fit at all. One difference between the laboratory measurements and the January storm is that the latter was at depth limited wave conditions, where the lab measurements were performed with relatively deep water. More investigation is required to come to a good explanation for the different b-values.
